LAWRENCE
LIVERMORE
NATIONAL
LABORATORY

LLNL-TR-648143

A Visual Description of the Concrete Exterior of the Cactus Crater Containment Structure

October 2013

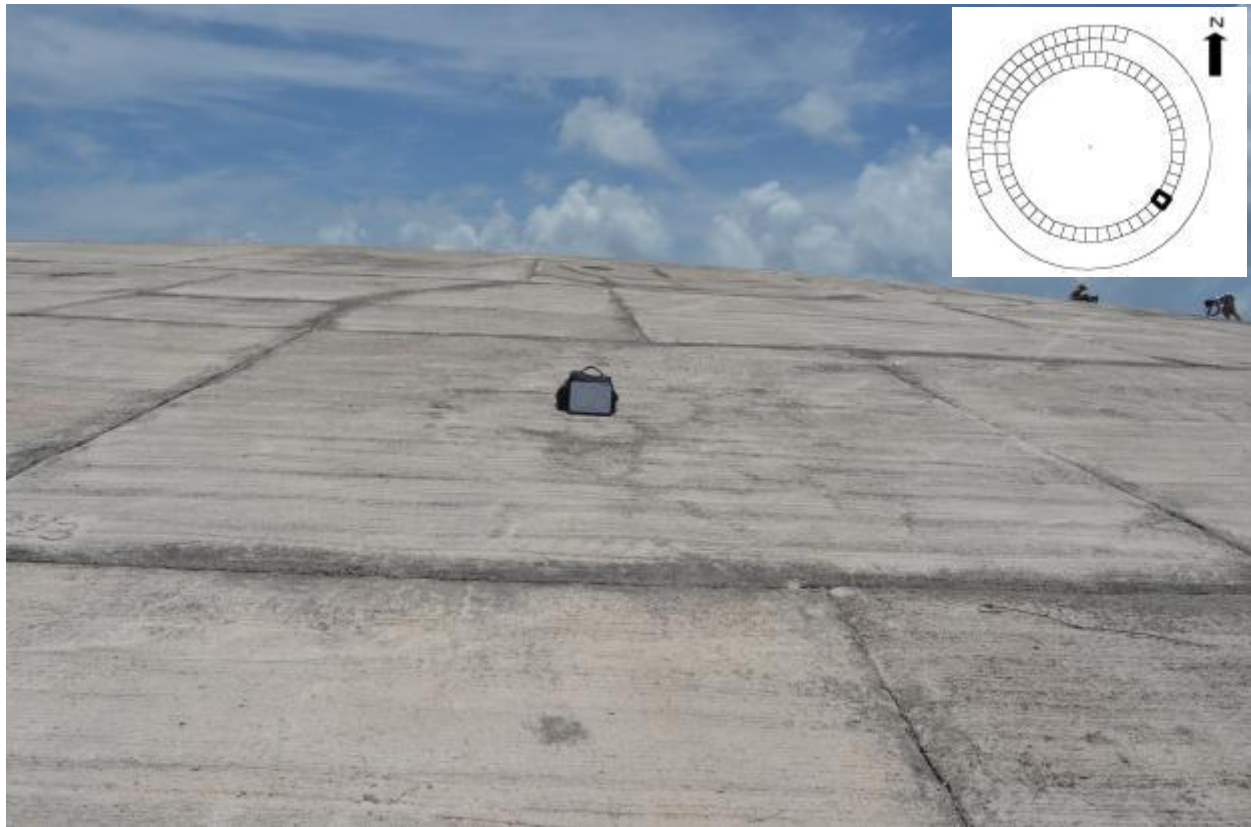
CAP SECTION LOCATION: Panel C22_duplicate (position C24)

The panel occupies position C24. Cracks along the seam lines appear to be deeper and more obvious. Spalling of concrete in the lower right-hand corner – the affected section of concrete occupies an area approaching 1 m². A small void about 2 centimeters deep and 2 x 1-1.5 centimeters in area was also observed on the upper right-hand side of the panel.

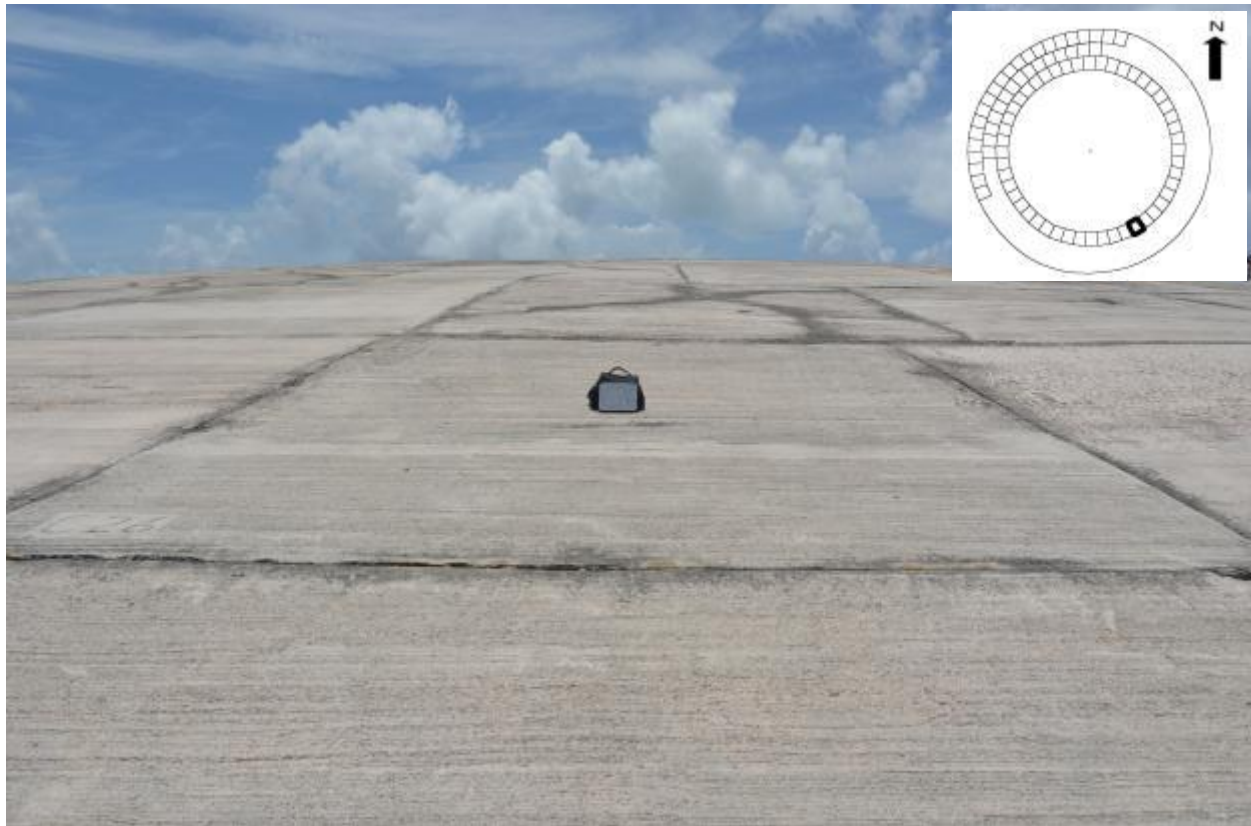
CAP SECTION LOCATION: Panel C27

No significant or obvious interior cracks extending across the top of the panel. Very minor spalling of concrete observed in the lower right corner. Some minor spalling of concrete is evident along the lip overhanging the upper left seam of the panel. Rooting vegetation removed from along the panel seams.

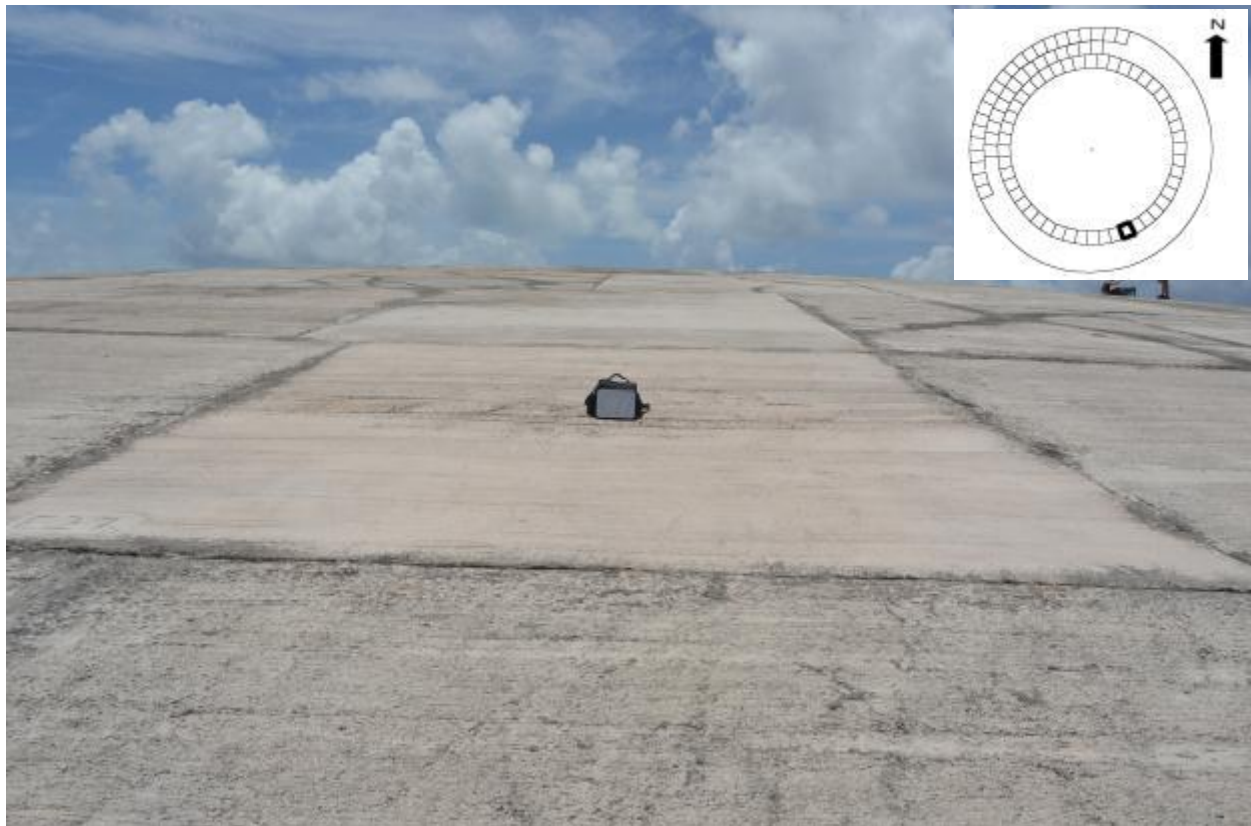
CAP SECTION LOCATION: Panel C28

No significant or obvious interior cracks extending across the top of the panel. The cracks along the seam lines appear to be deeper and more obvious compared with panels in adjacent ring rows. Very minor spalling of concrete observed in the lower right-hand corner of the panel. Some minor spalling of concrete observed along the bottom seam forming the intersecting corner between panel B33 and B34 below.

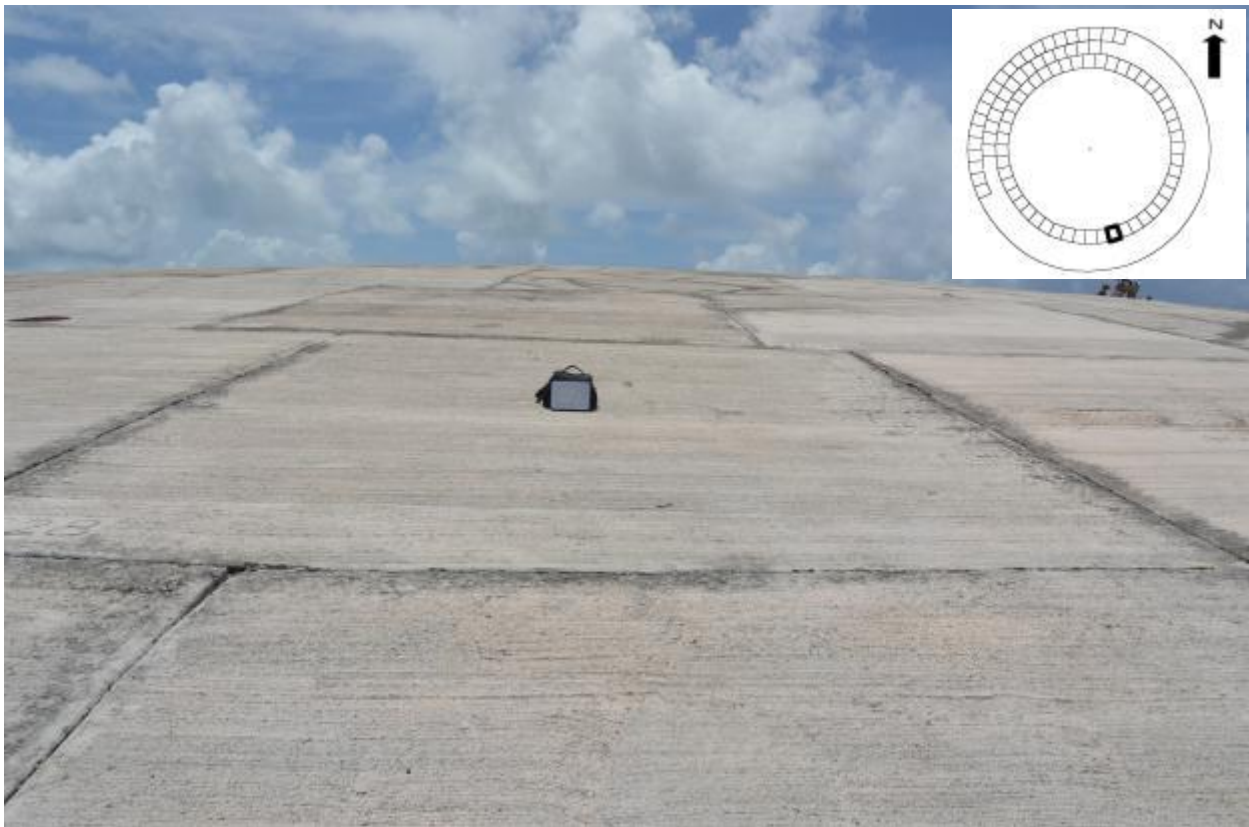
CAP SECTION LOCATION: Panel C29

No significant or obvious interior cracks extending across the top of the panel. Some spalling of concrete is evident along the lip overhanging the lower and left seams of the panel. Minor spalling of concrete also observed along the right side of the upper seam.

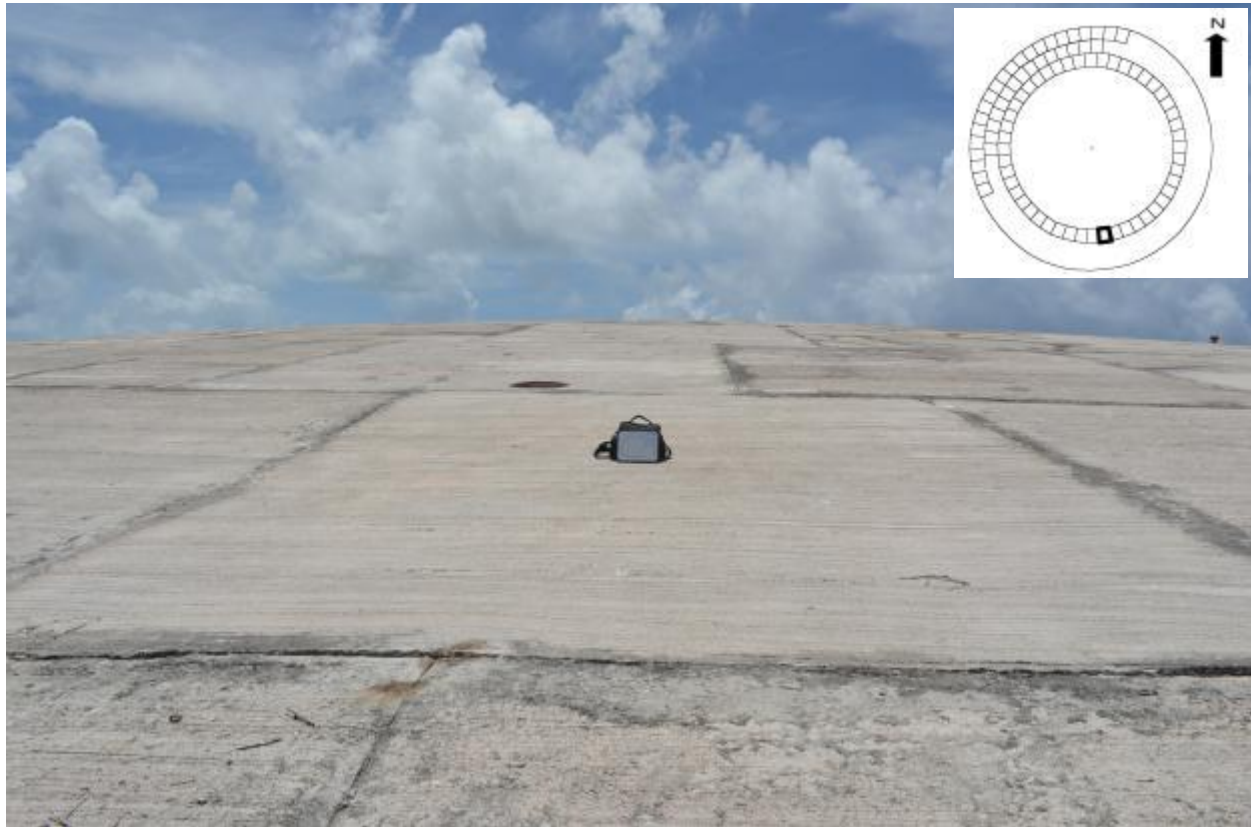
CAP SECTION LOCATION: Panel C30

No significant or obvious interior cracks extending across the top of the panel. The cracks along the panel joints appear to be deeper and more obvious compared with panels in adjacent ring rows.

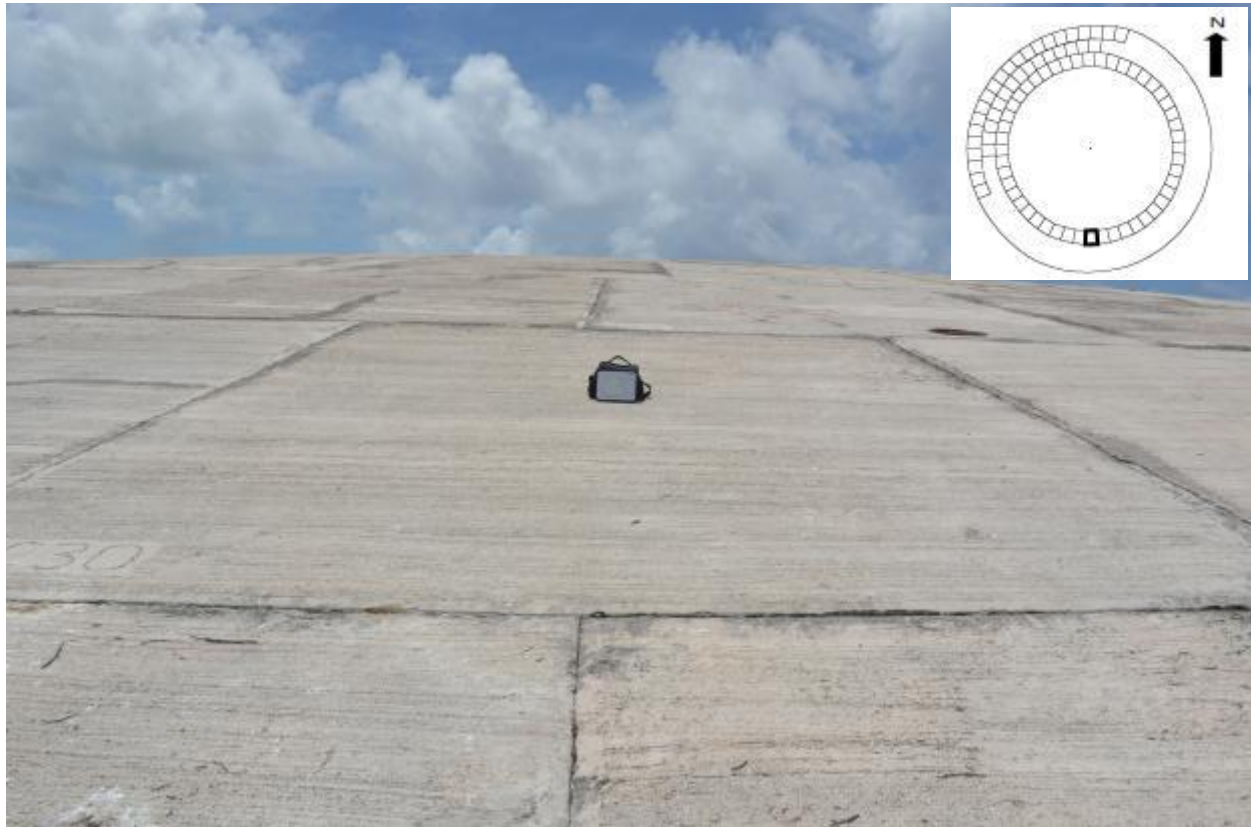
CAP SECTION LOCATION: Panel C31

Rooting vegetation removed from along the panel seams. Some spalling/cracking of concrete observed along the bottom seam adjacent the intersecting corner between panel B36 and B37. A surface crack extends out from the bottom of the panel and then forms a fork to the left and right edges at about a mid-point up the panel. Please note the crack line can easily be traced by observing the discoloration in the photo (refer to photo below).

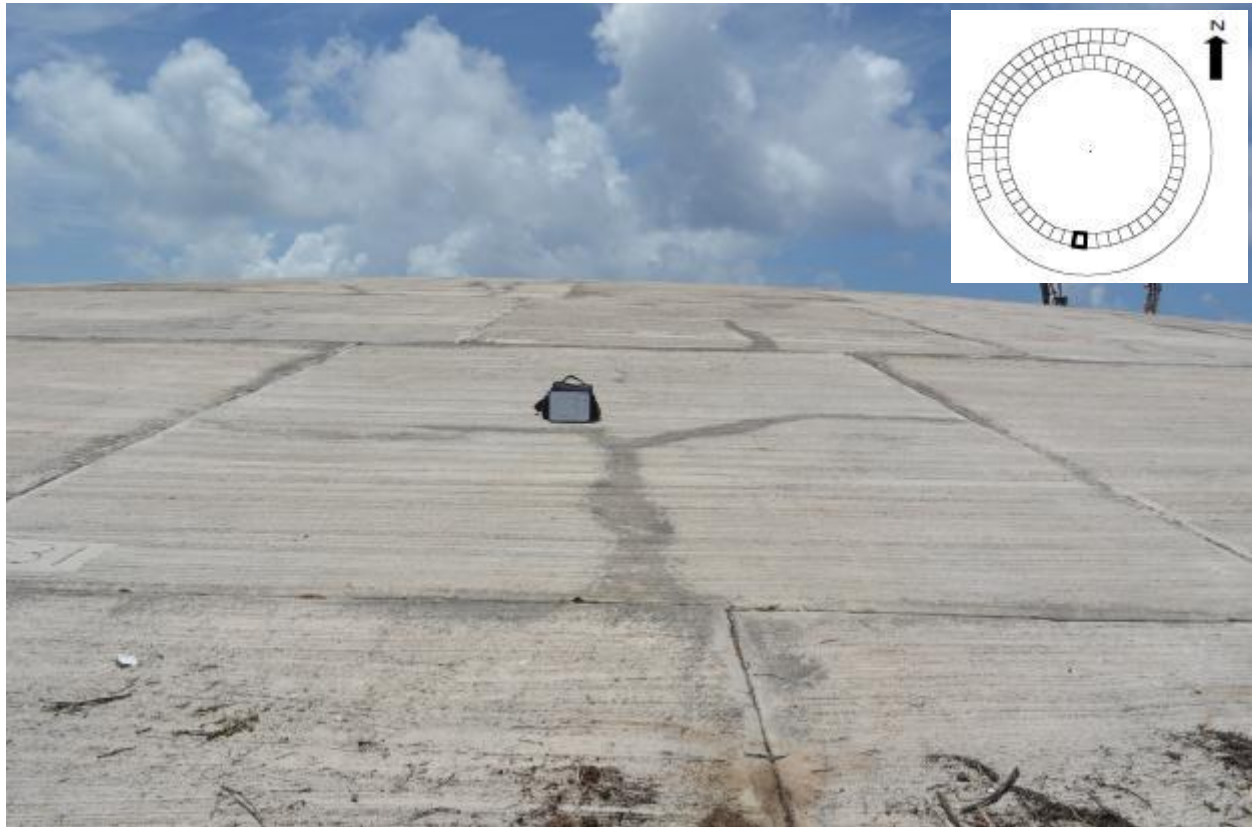
CAP SECTION LOCATION: Panel C32

No significant or obvious interior cracks extending across the top of the panel. Rooting vegetation removed from along the panel seams. Some spalling/cracking of concrete observed in the bottom left-hand corner of the panel.

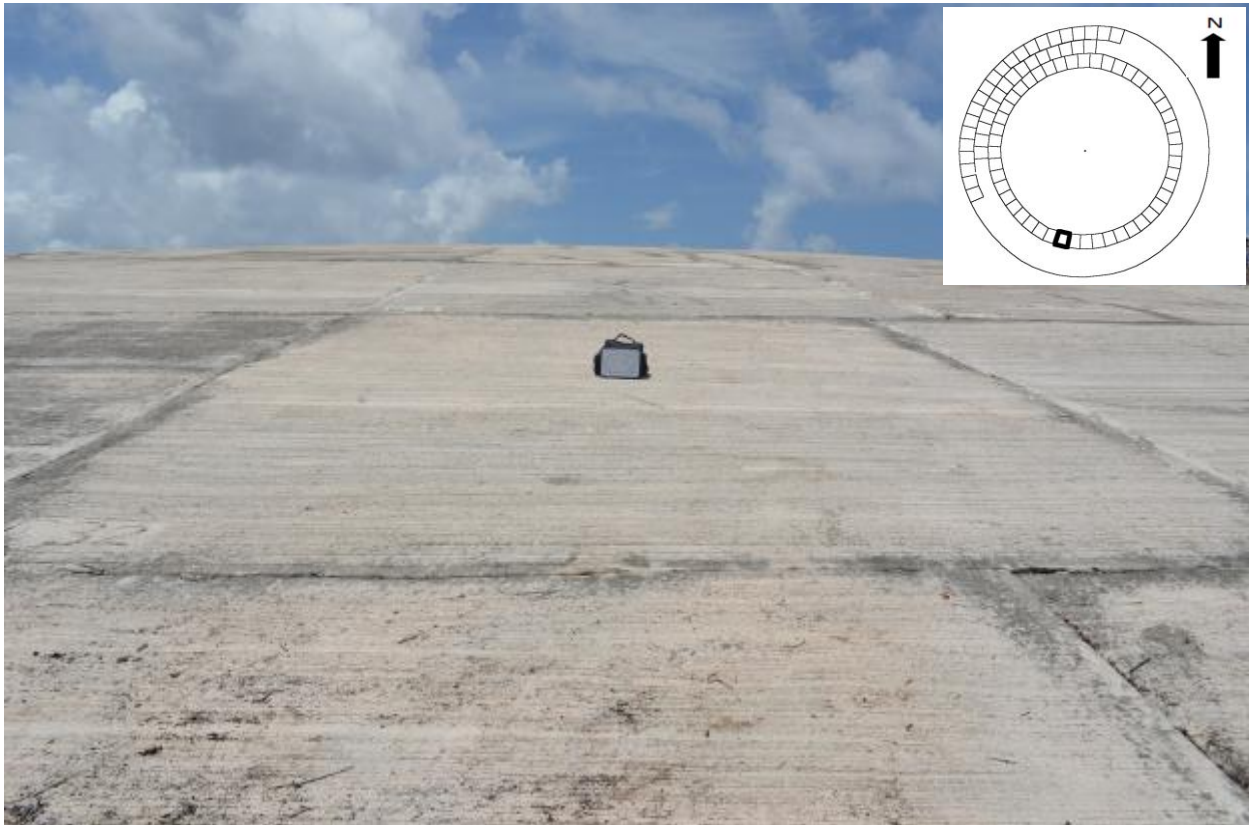
CAP SECTION LOCATION: Panel C33

The panel has a rough and weathered appearance. The cracks along the panel joints appear to be deeper and more obvious compared with those appearing around panels on adjacent ring rows. A surface crack was observed extending across the segment at a mid-point up the panel.

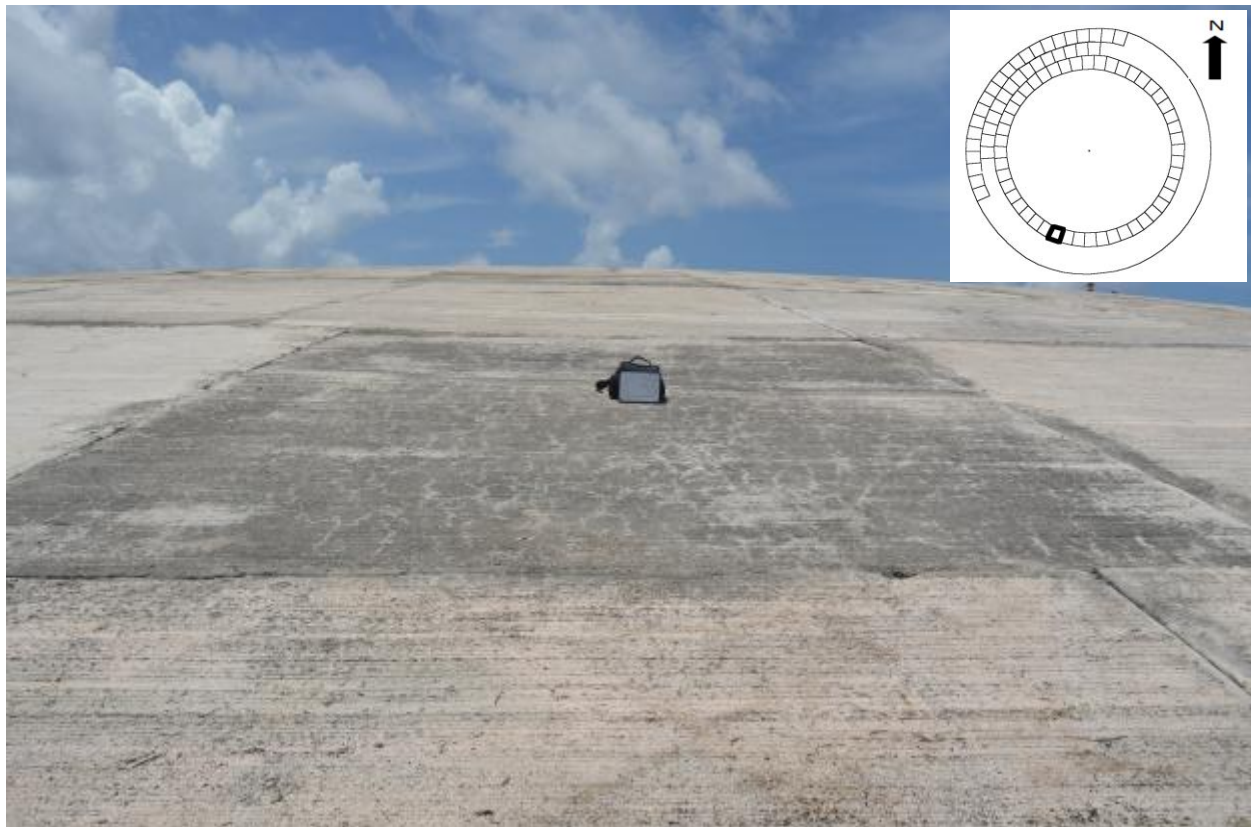
CAP SECTION LOCATION: Panel C34

No significant or obvious interior cracks extending across the top of the panel. The cracks along the panel joints appear to be deeper and more obvious compared with those appearing around panels on adjacent ring rows. Some spalling/cracking of concrete observed in the upper right-hand corner of the panel.

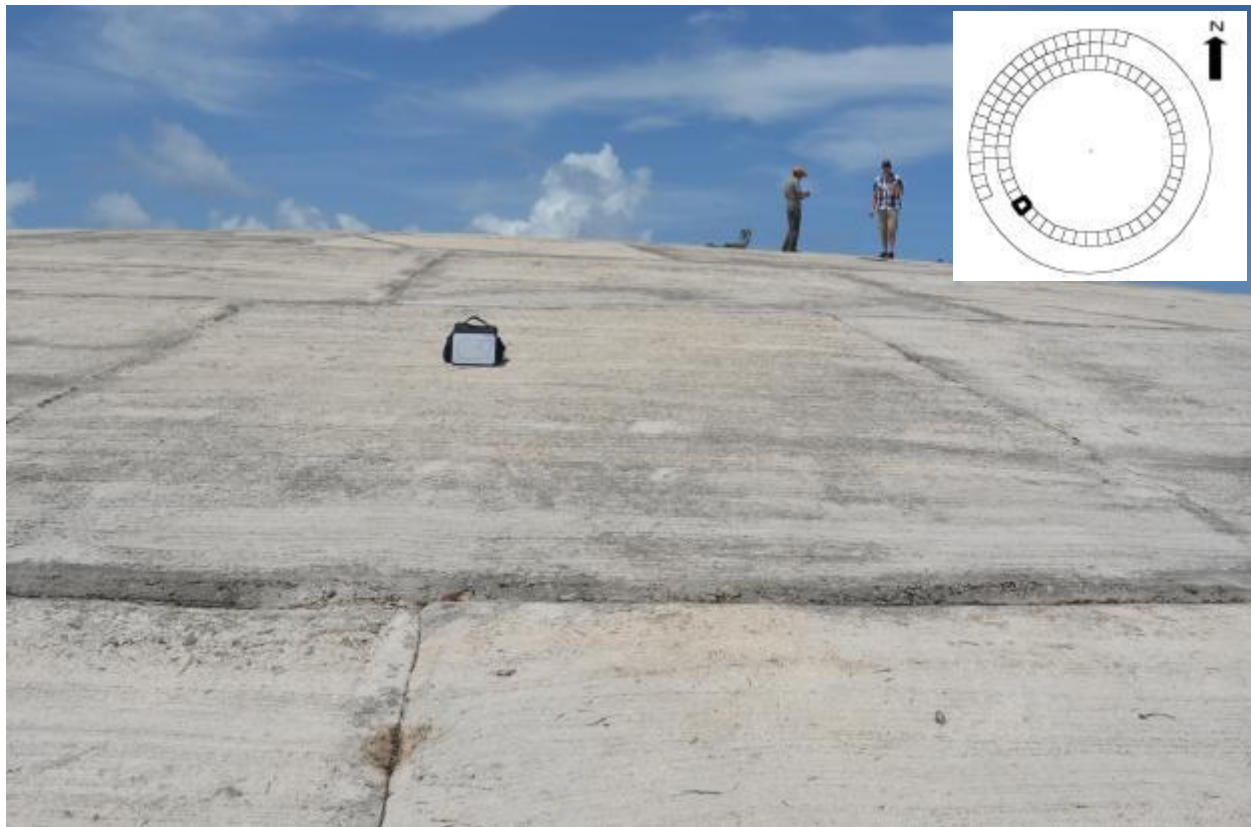
CAP SECTION LOCATION: Panel C38

No significant or obvious interior cracks extending across the top of the panel. Rooting vegetation removed from along the panel seams. Some spalling/cracking of concrete observed along the upper seam of the panel.

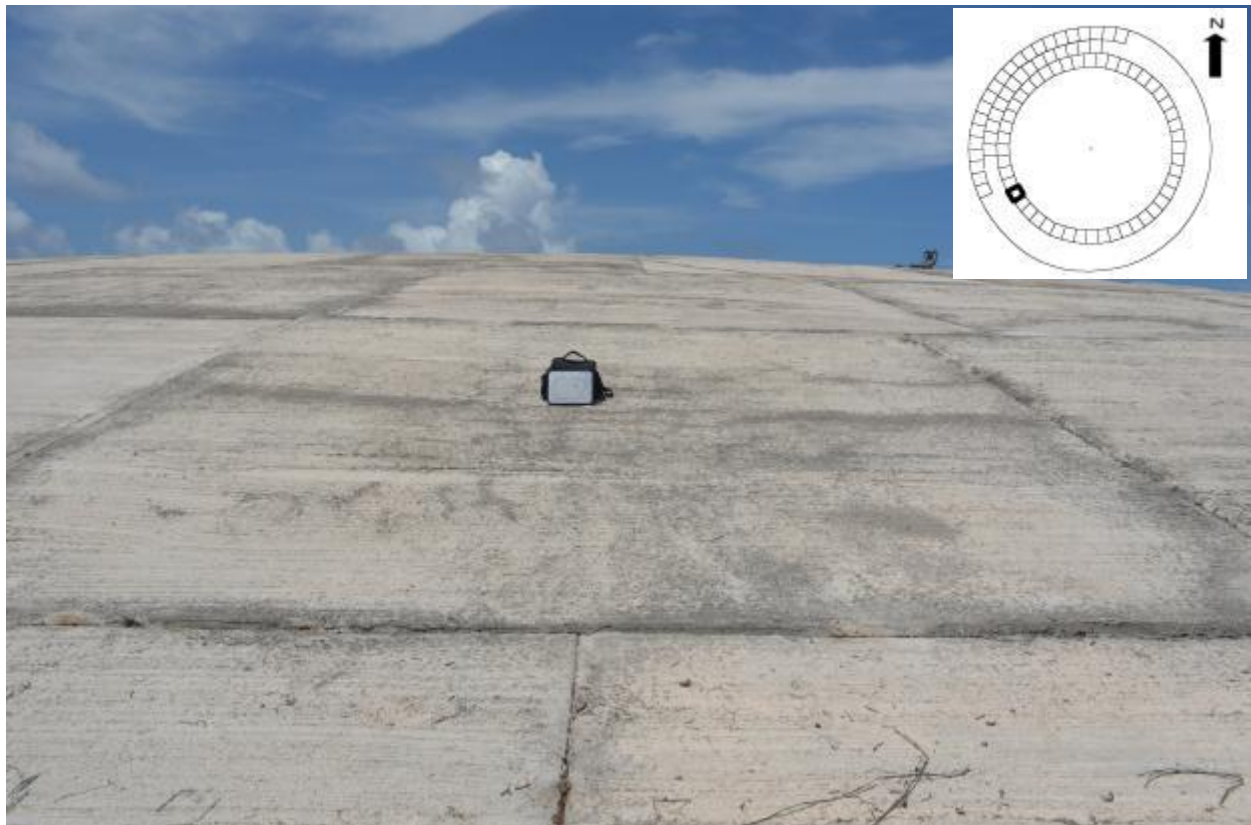
CAP SECTION LOCATION: Panel C39

No significant or obvious interior cracks extending across the top of the panel. Rooting vegetation removed from along the panel seams. Some spalling/cracking of concrete observed in the lower left-hand corner of the panel.

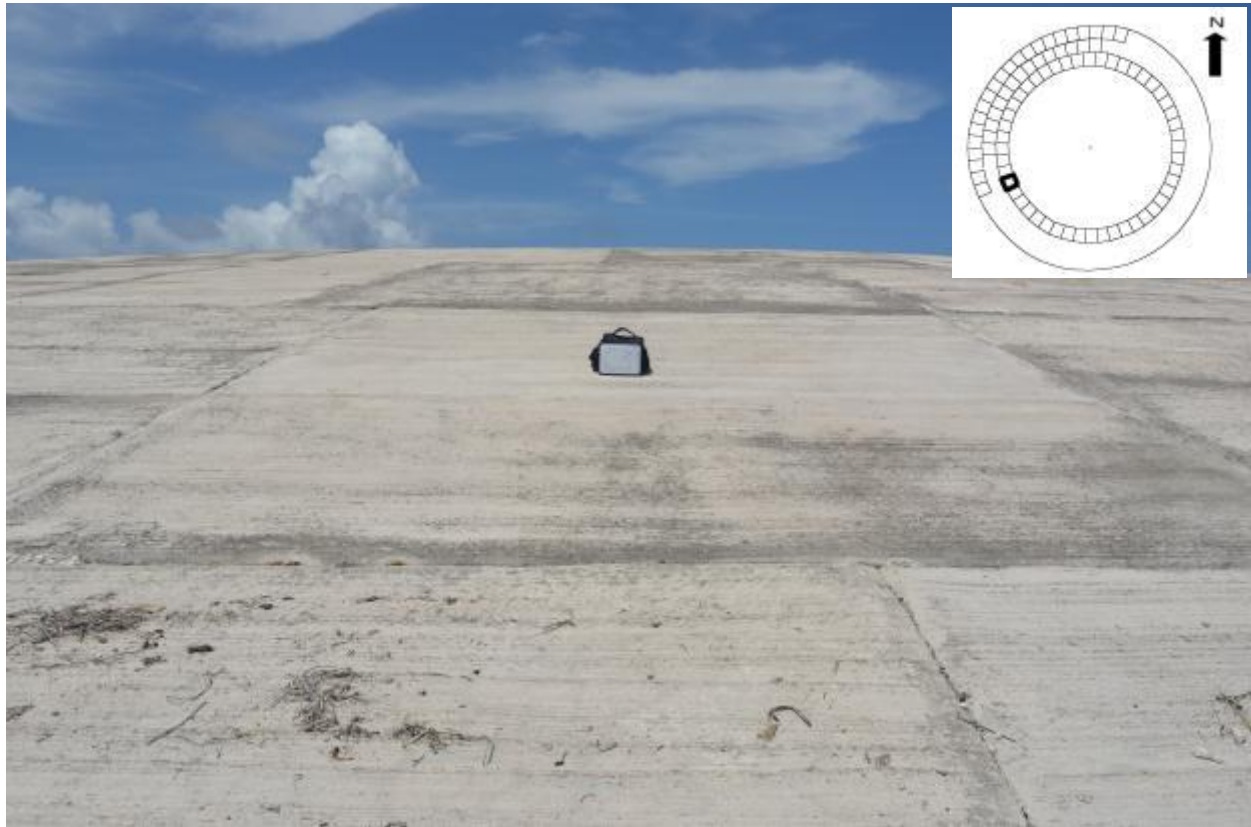
CAP SECTION LOCATION: Panel C40

Rooting vegetation removed from along the panel seams. Some minor surface cracks traversing across the panel that appear to coincide with the dark shaded areas shown in the photo below.

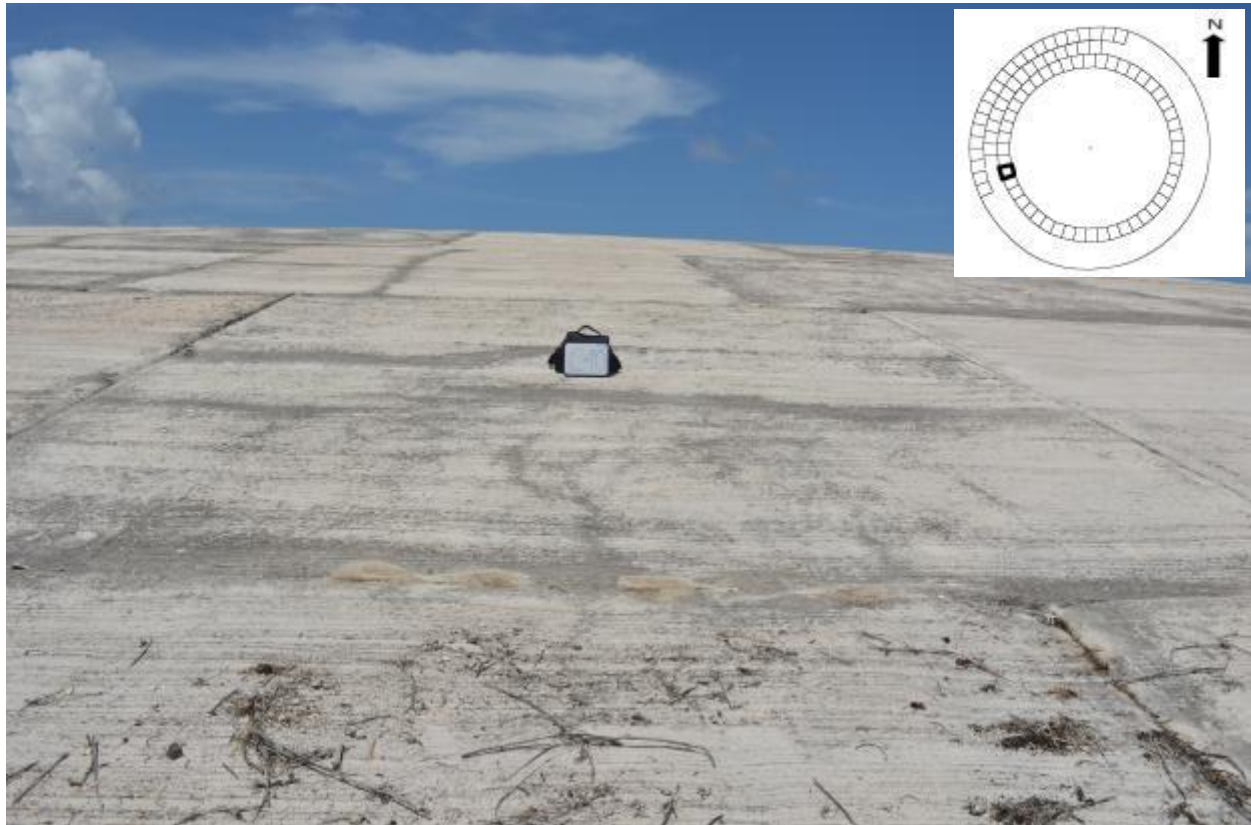
CAP SECTION LOCATION: Panel C41

The panel has a rough and weathered appearance across the upper portion of the panel. Some spalling/cracking of concrete observed in the upper left-hand corner of the panel. Rooting vegetation removed from along the panel seams. Surface crack observed extending up from a central location along the bottom seam up to a distance of about 2 meters away from the top of the panel.

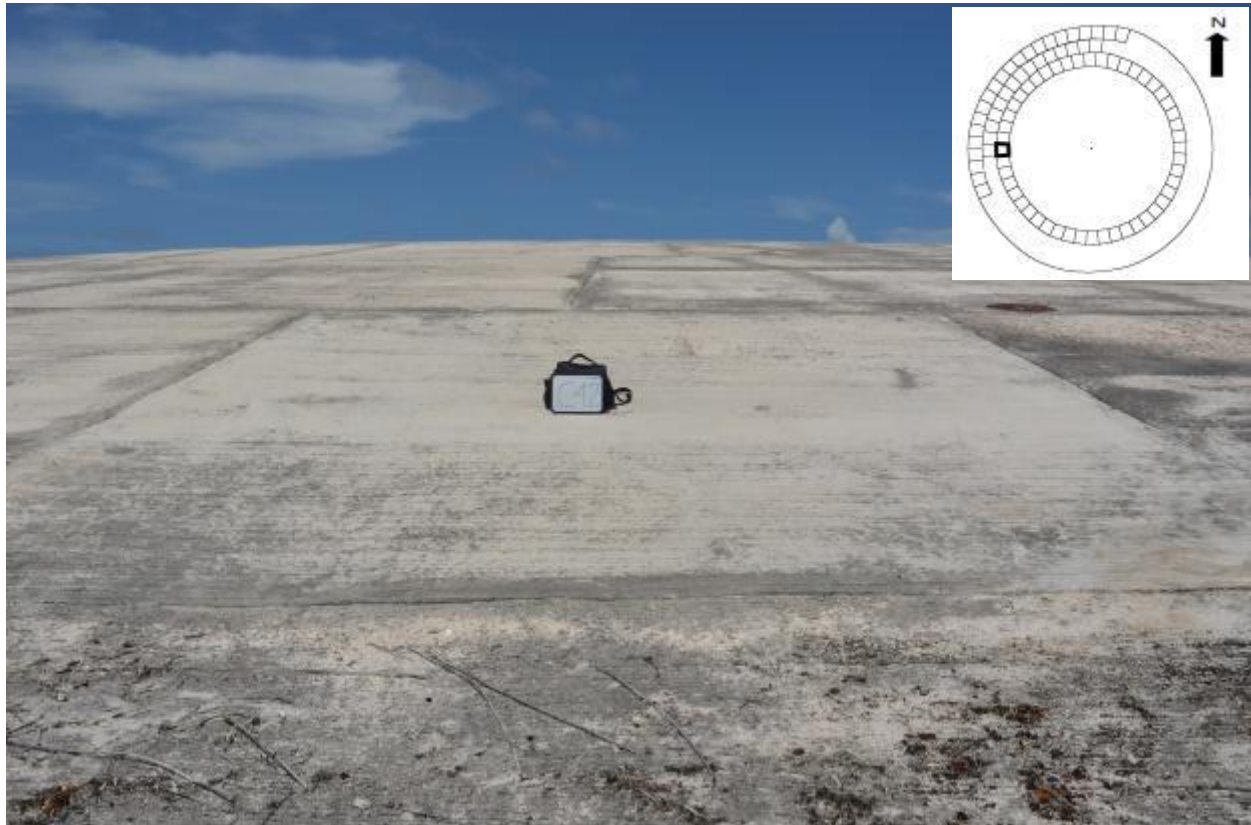
CAP SECTION LOCATION: Panel C43

Significant spalling of concrete observed in the upper left corner of the panel where the chipped out piece of concrete extends down to contaminated soil – cement grout waste pile mixture below. Some minor spalling/cracking of concrete also observed in the lower right-hand corner of the panel. Panel recommended for priority repair.

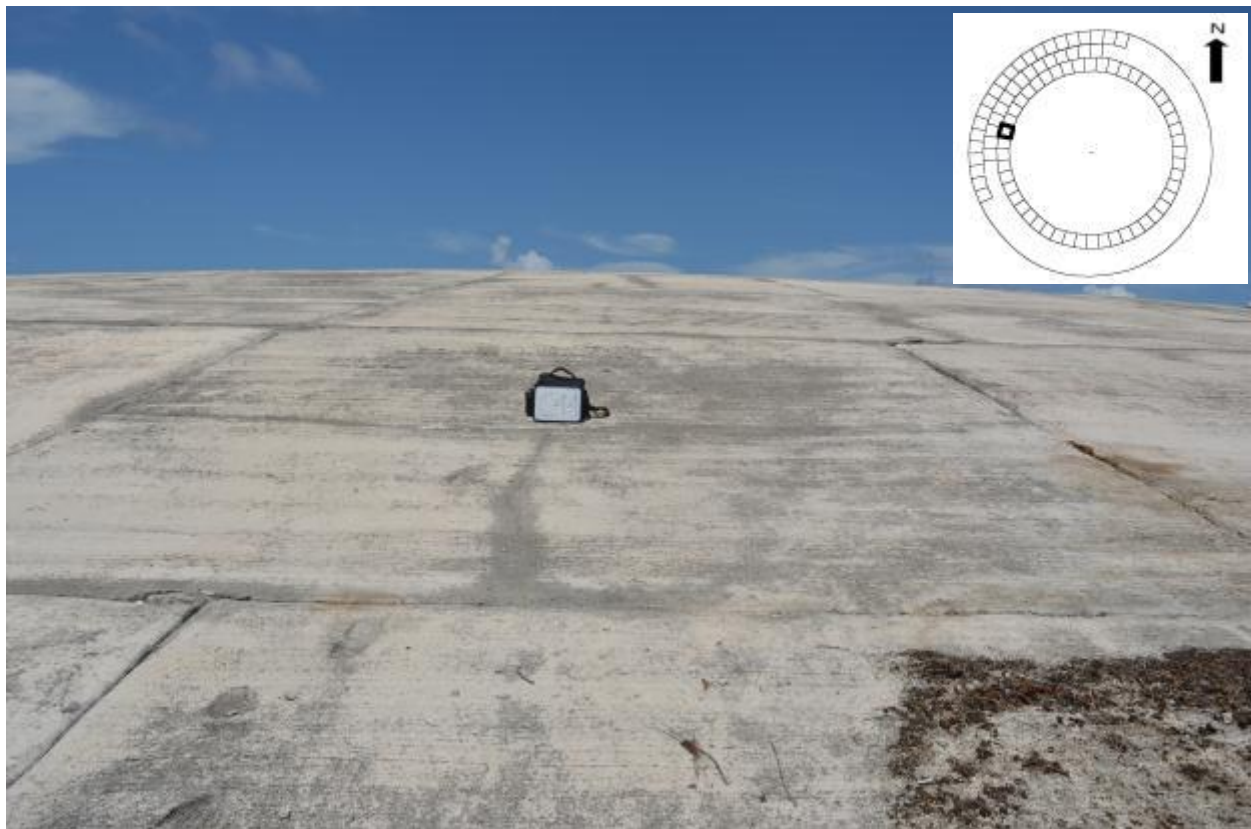
CAP SECTION LOCATION: Panel C45

The panel has a rough and weathered appearance. Also, the cracks along the panel joints appear to be deeper and more obvious compared with those appearing around panels on adjacent ring rows. A visible crack can be seen originating at intersecting corner between panel B57 and B58 on the bottom seam and extending up the panel for a distance of about 1 meter. There is also an visible crack traversing across the panel.

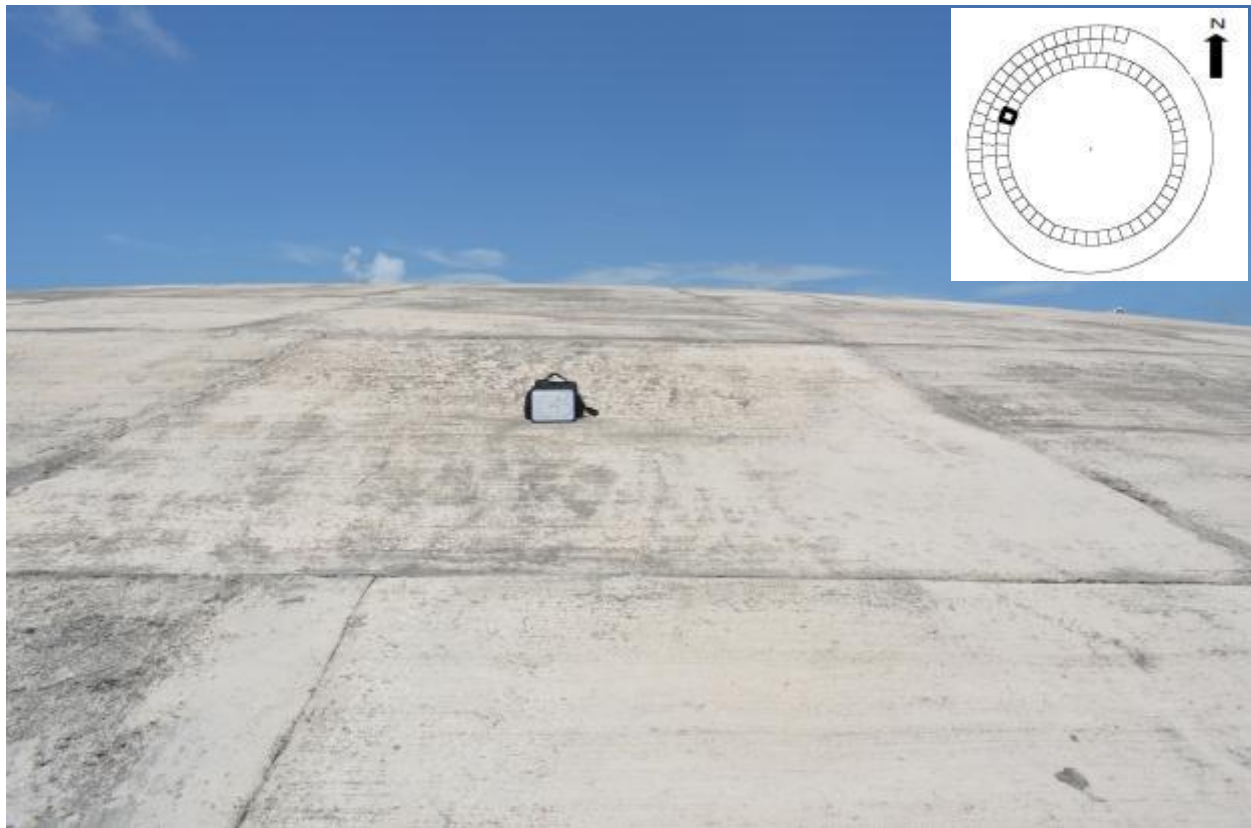
CAP SECTION LOCATION: Panel C46

No significant or obvious interior cracks extending across the top of the panel. Rooting vegetation removed from along the panel seams. Some spalling/cracking of concrete observed in the upper left-hand corner of the panel.

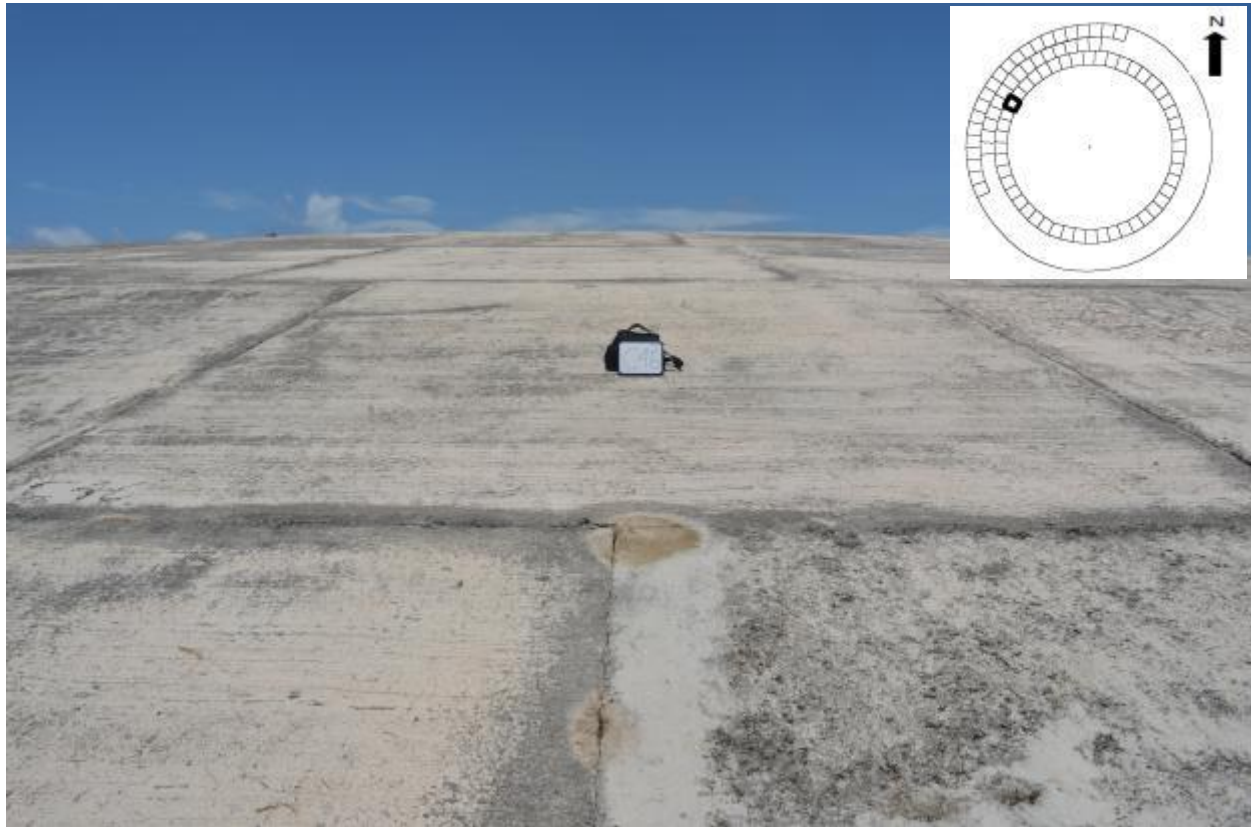
CAP SECTION LOCATION: Panel C47

No significant or obvious interior cracks extending across the top of the panel. The panel has a rough and weathered appearance. The cracks along the panel joints appear to be deeper and more obvious compared with those appearing around panels on adjacent ring rows. Rooting vegetation removed from along the panel seams.

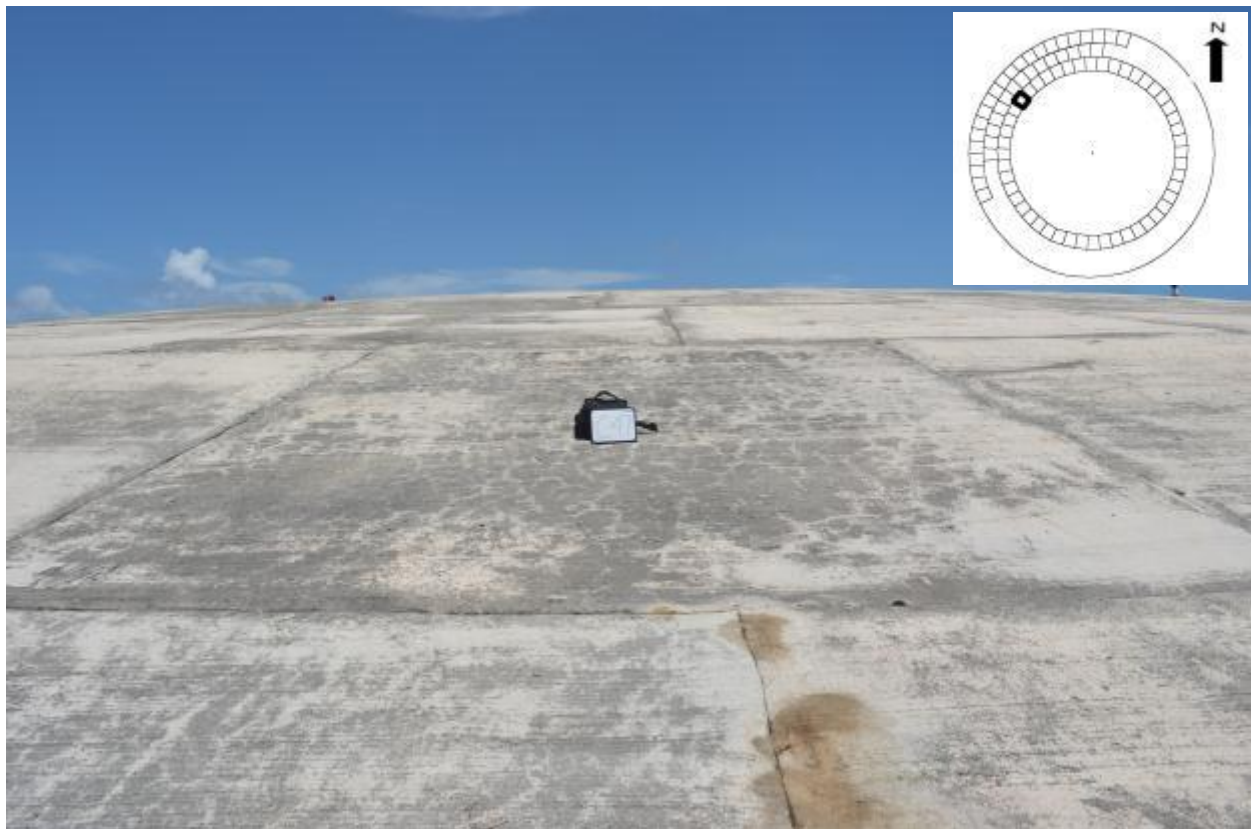
CAP SECTION LOCATION: Panel C48

No significant or obvious interior cracks extending across the top of the panel. The cracks along the panel joints appear to be deeper and more obvious compared with those appearing around panels on adjacent ring rows. Rooting vegetation removed from along the panel seams.

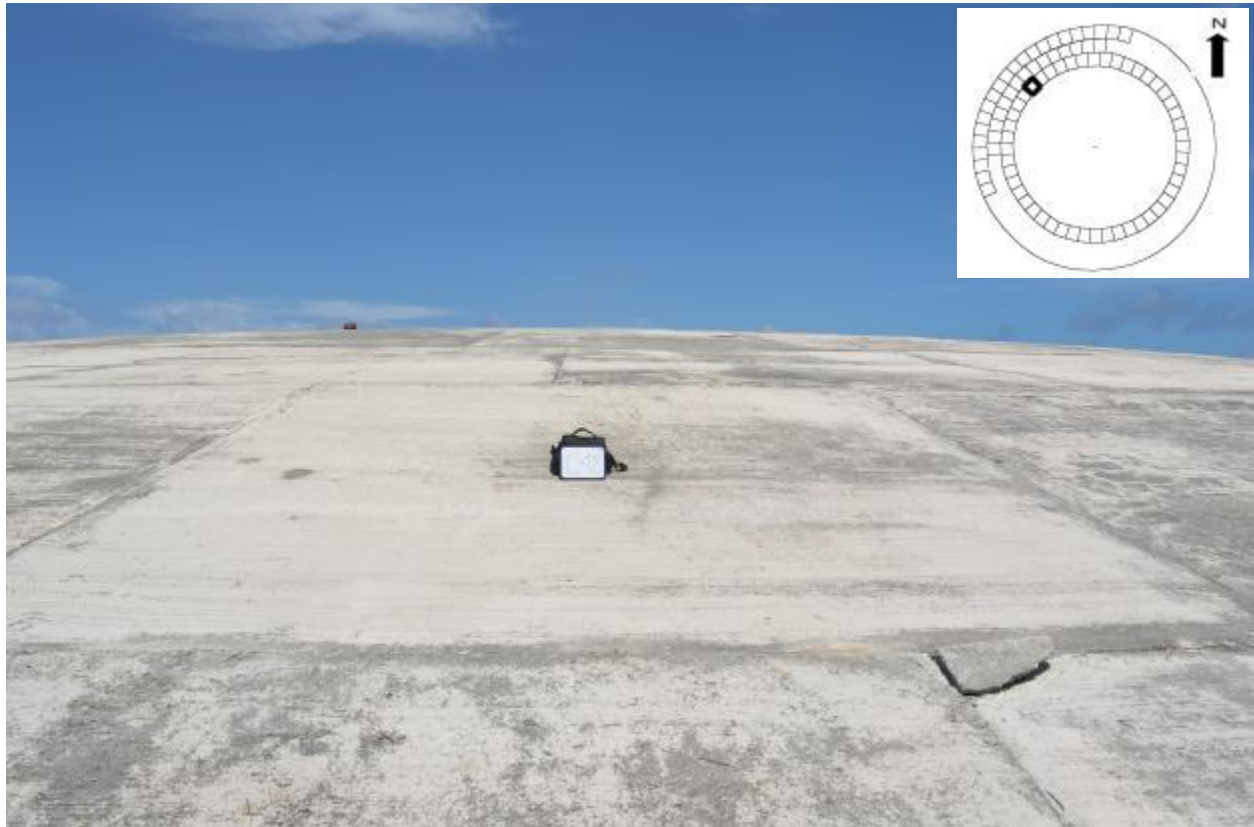
CAP SECTION LOCATION: Panel D1

Two main surface cracks extending up from the bottom seam intersecting with another crack traversing across the segment at about a mid-point up the panel. Rooting vegetation removed from along the panel seams. Minor spalling/cracking of concrete observed in the lower left-hand corner of the panel.

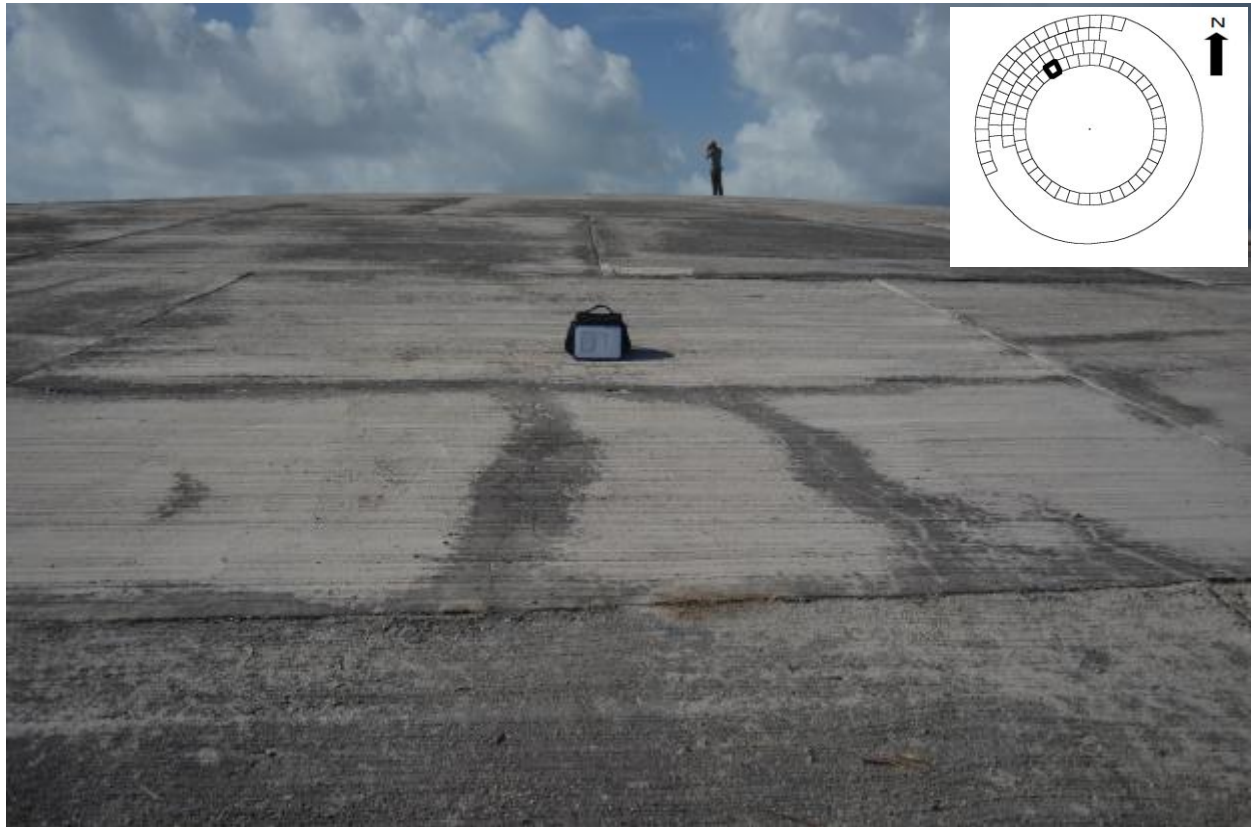
CAP SECTION LOCATION: Panel D2

Rooting vegetation removed from along the panel seams. Surface crack observed extending from left side of the bottom seam traveling up towards the upper seam intersecting at corner E1/E36 on the ring row above with a fork branching out to the left and right sides of the panel.
